Reconnecting a community in the aftermath of cyclone Seniang

Bridging Case Study

Dumlog Bridge, Philippines

Solution: Mabey Compact 200™

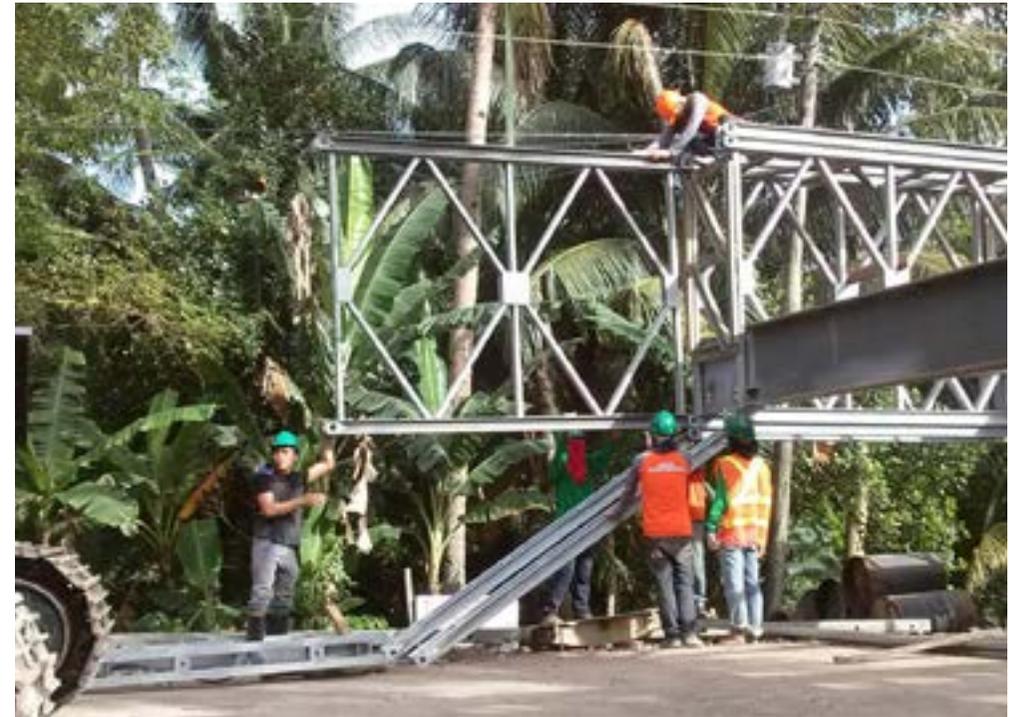
With a width of 7.35 metres allowing two lanes of traffic, the bridge is able to accommodate cars, buses and other heavy traffic. The 59 metre bridge has been installed over the existing concrete bridge and features 35 metre approaches on either side. Work to install the bridge was conducted 24 hours a day.

The two-lane, three-span Mabey Compact 200™ (Mabey C200™) temporary solution at Dumlog Bridge was assembled from components already held in stock for just such an emergency. Mabey has supplied modular bridging to the Philippines for many years as part of the President's Bridge Programme to improve the country's infrastructure. To date over 1600 bridges have been installed across the country for both infrastructure improvement and disaster relief.

Preparatory work for the Dumlog replacement bridge began 1st January, just two days after the permanent bridge was rendered unusable. Mabey C200™ bridge components were delivered over a six day period and installation started on the 8th January, with the structure completed just eight days later. There was added imperative to reopen the route quickly as the Sinulog Grand Parade was scheduled to take place two days after the bridge was opened.
